Technical Report 658

NAVAL ARCHITECTURAL RESEARCH FOR WOMEN ABOARD SHIP

March 1981

Final Report: March – September 1980

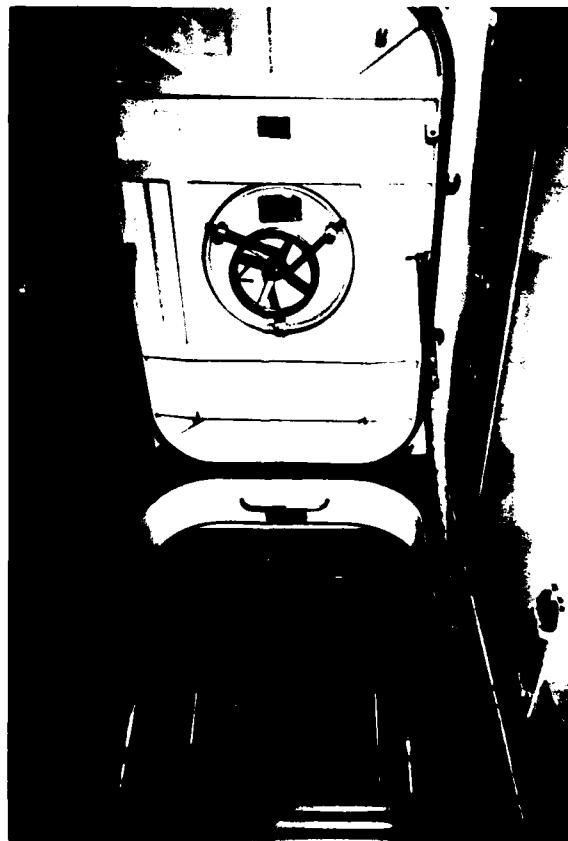
Figure 17. Stairwell.

Tripping hazards are often elicited by a 6-inch lip that surrounds the open stairwell (see figure 17). Lack of adequate footing around many of these stairwells added to the problem.
